CATHODIC PROTECTION SYSTEM

FOR FLEET MOORINGS

CATHODIC PROTECTION SYSTEM FOR FLEET MOORINGS

Technical Report R-702

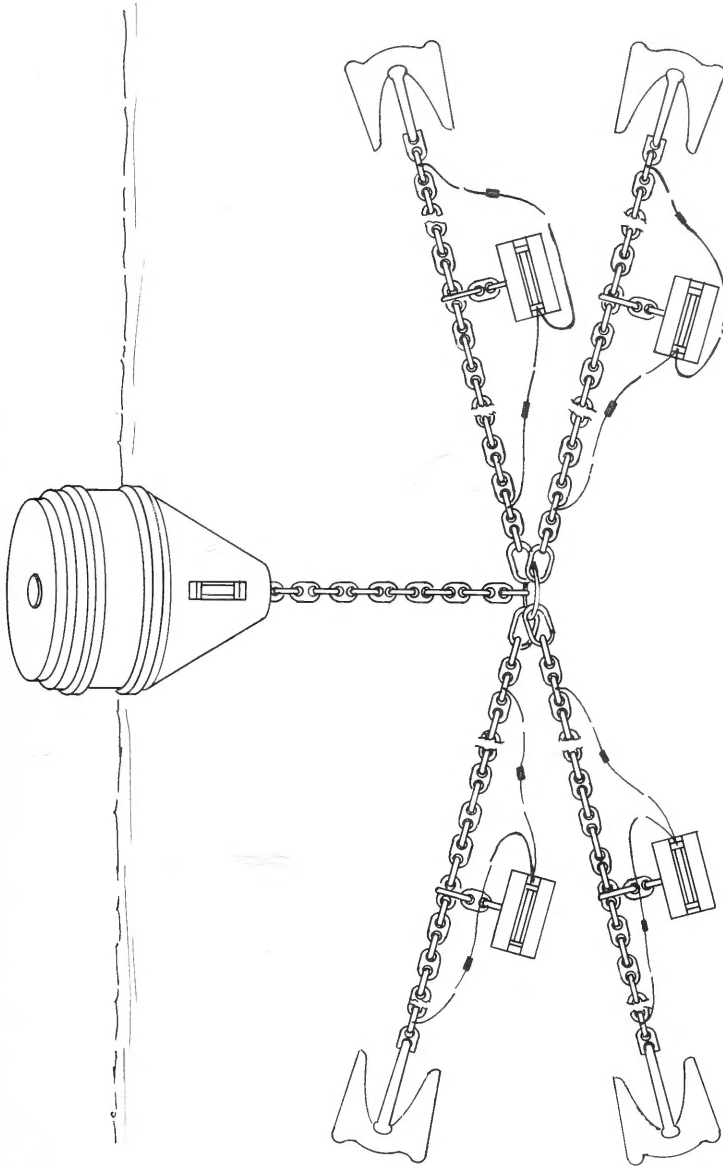
Fabrication. A standard Fleet mooring was modified by the Public Works Center, San Diego for in-service testing of the cathodic protection system. The mooring consisted of a Mark II peg-top buoy with a riser-chain and four ground legs. Each ground leg had a sinker block located 135 feet from the ground ring and an anchor located 90 feet from the sinker block. Figure 1 shows the layout of the ground tackle with the location of the anodes and remote ground cables indicated.

Figure 1. Design of initial cathodic protection system utilizing magnesium anodes.

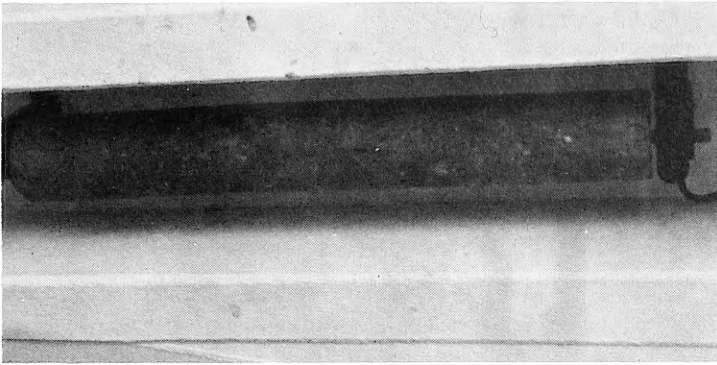
Two sea chests were built into opposite sides of the buoy cone, each to house a cathodic protection unit. The modified buoy was sandblasted to white metal (Figure 2) and coated with the phenolic mastic coating system described in Reference 3. The automatic control heads were bolted to threaded studs located inside the sea chests, and 80-pound magnesium anodes were secured between them and the lower mounting brackets (Figure 3). Nylon spacers were used to isolate the anodes electrically from the buoy; thus, current from the anodes had to pass through the control heads and the connected ground cables before reaching the buoy. Each of the two ground cables was threaded through a series of chain links that were welded to the bottom flange and then was welded to the flange at a point opposite the sea chest from which it came (Figure 4). Immediately before placing the buoy in service, a square-foot section of coating on the underwater portion of the buoy was sandblasted to bare steel (Figure 4), giving an exposed steel specimen on which the effect of cathodic protection could be determined visually.

Figure 3. Cathodic protection unit in sea chest in buoy.

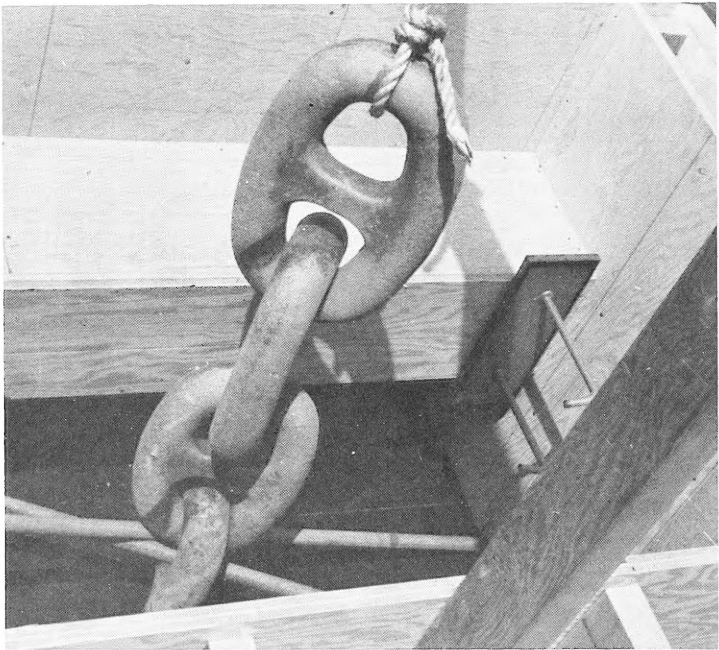
Four concrete sinker blocks were specially fabricated to hold the cathodic protection units for the ground legs. Each sinker block was prepared in a wooden form with a slot cut out to house a unit. Three and one-half 2-1/4-inch chain links were cast into the block as shown in Figure 5. Threaded J-bolts used to secure the cathodic protection equipment in place were also cast into the concrete. A cathodic protection unit similar to those on the buoy was attached to each of the sinker blocks. Each control head had two 100-foot ground cables of no. 2 neoprene-insulated, stranded copper wire attached to them.

Figure 5. Chain links in wooden form ready for casting of concrete sinker block.

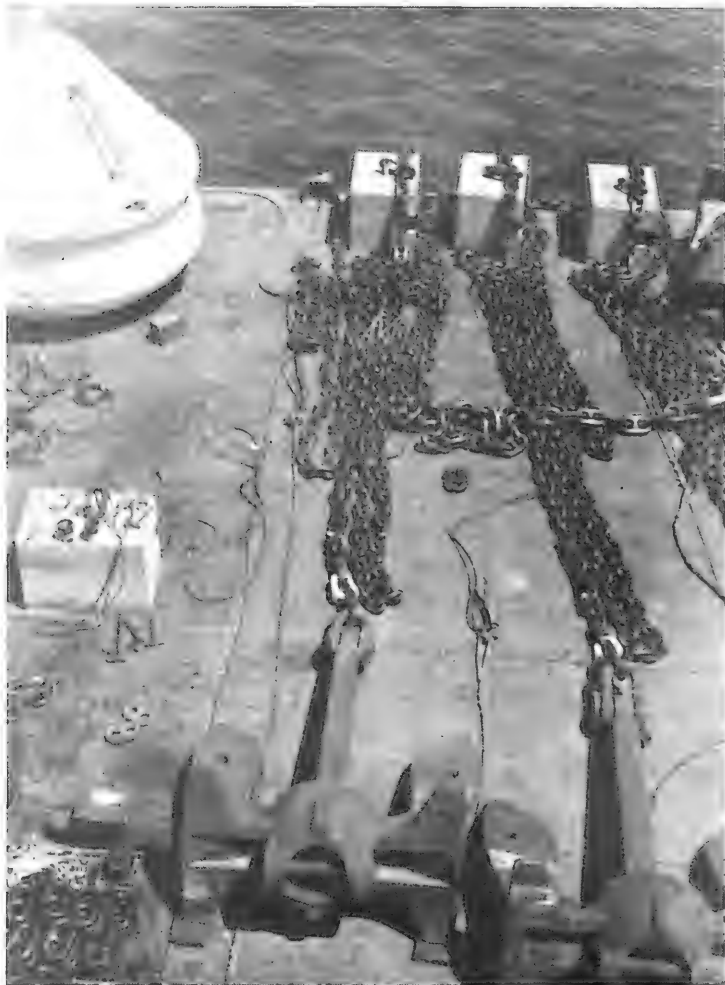
Installation. The entire mooring complex was placed on the deck of a floating crane in position for laying (Figure 6). The two ground cables connected to the control head in each sinker block were coiled and tucked inside the groove in the block (Figure 7) to protect them from damage during laying operations. A 75-foot length of similar cable was welded to the second A-link from the ground ring, and a 50-foot length of cable was welded to the second A-link from the anchor of each ground leg. These cables were also coiled tightly and tied in place prior to laying operations. A tight mooring was carefully placed in its assigned location in the San Diego Bay.

Figure 6. Initially designed system prepared for laying.

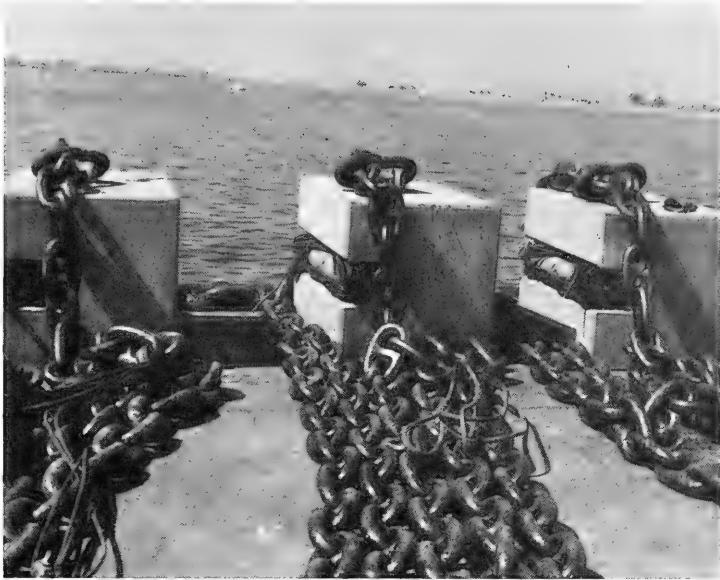
Figure 7. Sinker blocks housing cathodic protection units with coiled cables prior to laying of system.

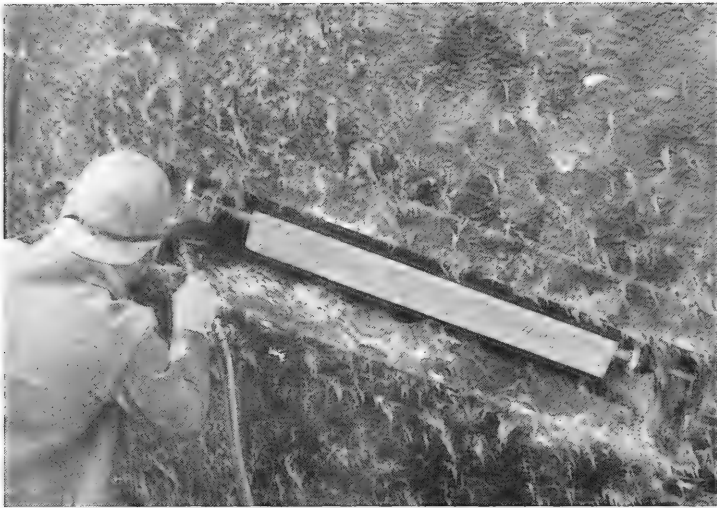
inside the steel pipe on which the zinc anode had been cast and were silver-soldered to the pipe (Figure 8). Thus, the control heads were bypassed in the circuitry and served merely as securing brackets. The connections were wrapped with electrical tape, and the buoy was returned to the water,

Figure 8. Silver soldering of ground cable to steel pipe supporting the zinc anode.

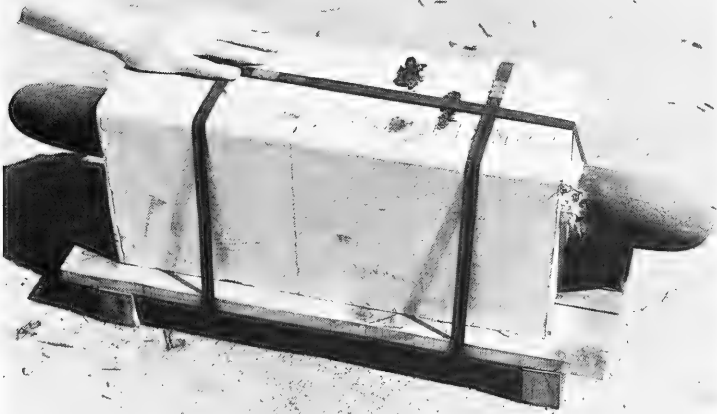
The anodes in the new cathodic protection system had to be specially manufactured. They were prepared by casting SA-3 zinc alloy on a 2-1/2-inch-thick, 35-inch-long steel link. The zinc casting was 1.8 feet long, was approximately 6.6 ft² in total surface area, and had a trapezoidal cross section. The entire anode weighed approximately 485 pounds (Figure 9).

Figure 9. Specially cast zinc anode on chain link.

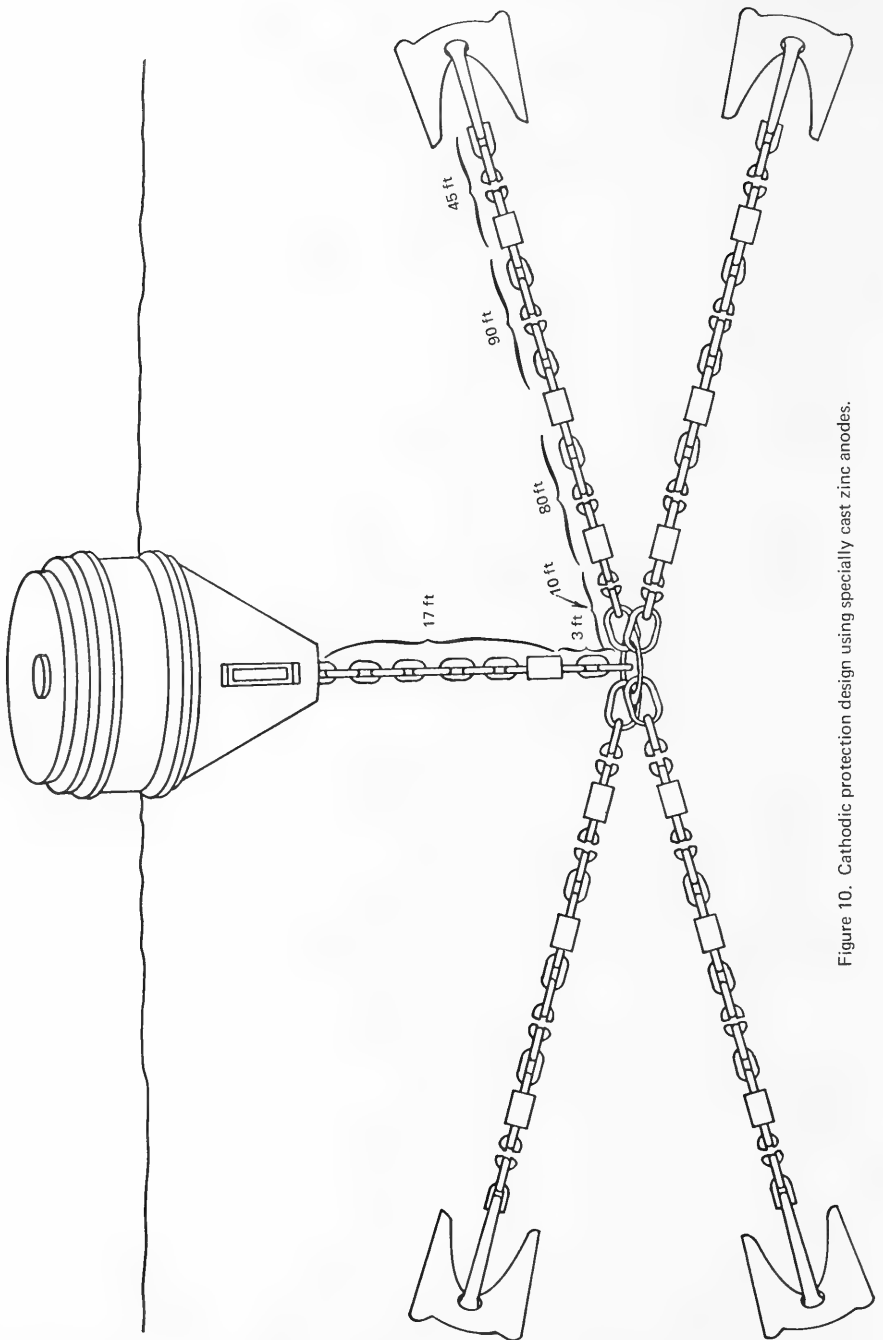
The design of the cathodic protection system is shown in Figure 10. Two of the smaller zinc anodes (approximately 144 pounds) used in the previous study on buoys were located in the sea chests on opposite sides of the buoy cone. Three of the special anodes were inserted in each leg, and one was inserted in the riser-chain approximately 3 feet above the ground ring. The anodes were secured into the recoated ground tackle using standard detachable links. With this method no place on the chain was farther than 45 feet from an anode.

Figure 10. Cathodic protection design using specially cast zinc anodes.

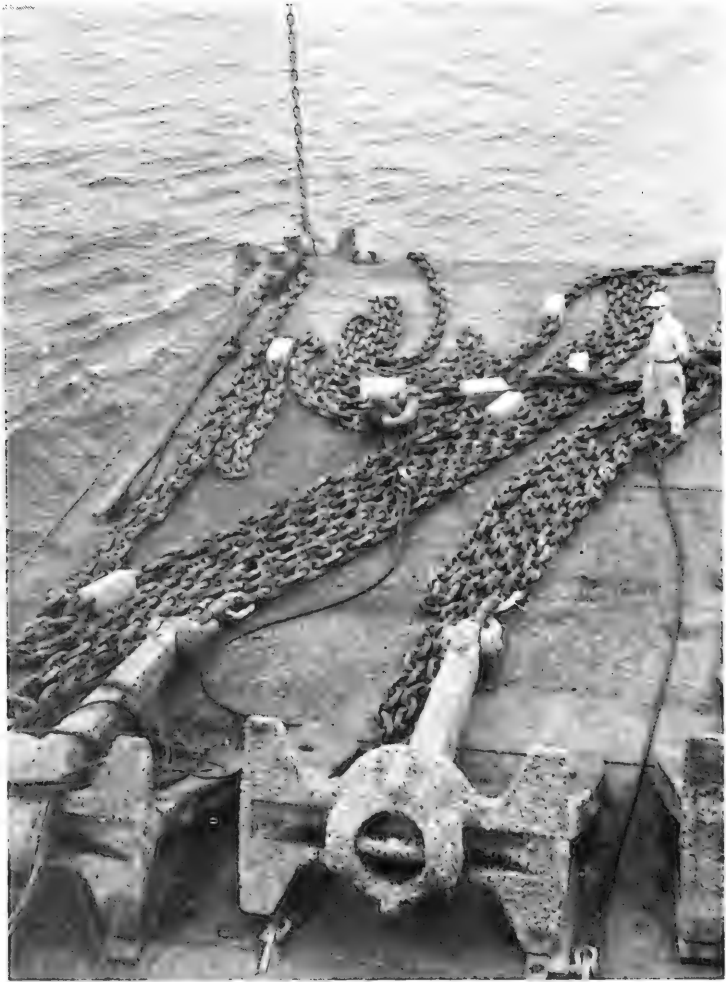
The entire mooring complex was layed out on the deck of a floating crane (Figure 11) and later carefully lowered into service to avoid abrasion or impact damage to the anodes.

Figure 11. Ground tackle with specially cast anodes on deck of floating crane rigged for laying.

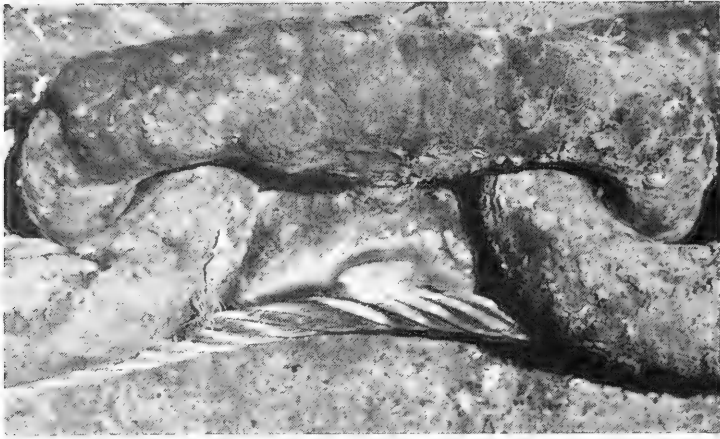
Figure 12. Cable silver-soldered to chain link.

In order to determine ways to obtain better electrical continuity between chain links, two of the ground legs were slightly modified 8 months after the readings of Table 5 were made. One leg was removed from the water, and those portions of the chain links that come into contact with each other were sandblasted using the portable sandblast equipment aboard a floating crane. This ground leg was then returned to its normal location underwater. A second ground leg was removed from the water and layed out on the deck of the floating crane. Three 3/4-inch-diameter galvanized steel cables were woven back and forth through every sixth link. One cable extended from the A-link nearest the anchor to the A-link nearest the zinc anode 45 feet away. The other two cables extended between the zinc anodes which were 90 and 80 feet apart. The ends of each cable were silver-soldered to the A-link nearest the anode (Figure 12), and the cable was also silver-soldered approximately every 9 feet to the chain. Sufficient slack was allowed between fixed positions so that there was no strain on the cable. This ground leg was then returned to its normal position with no difficulty.

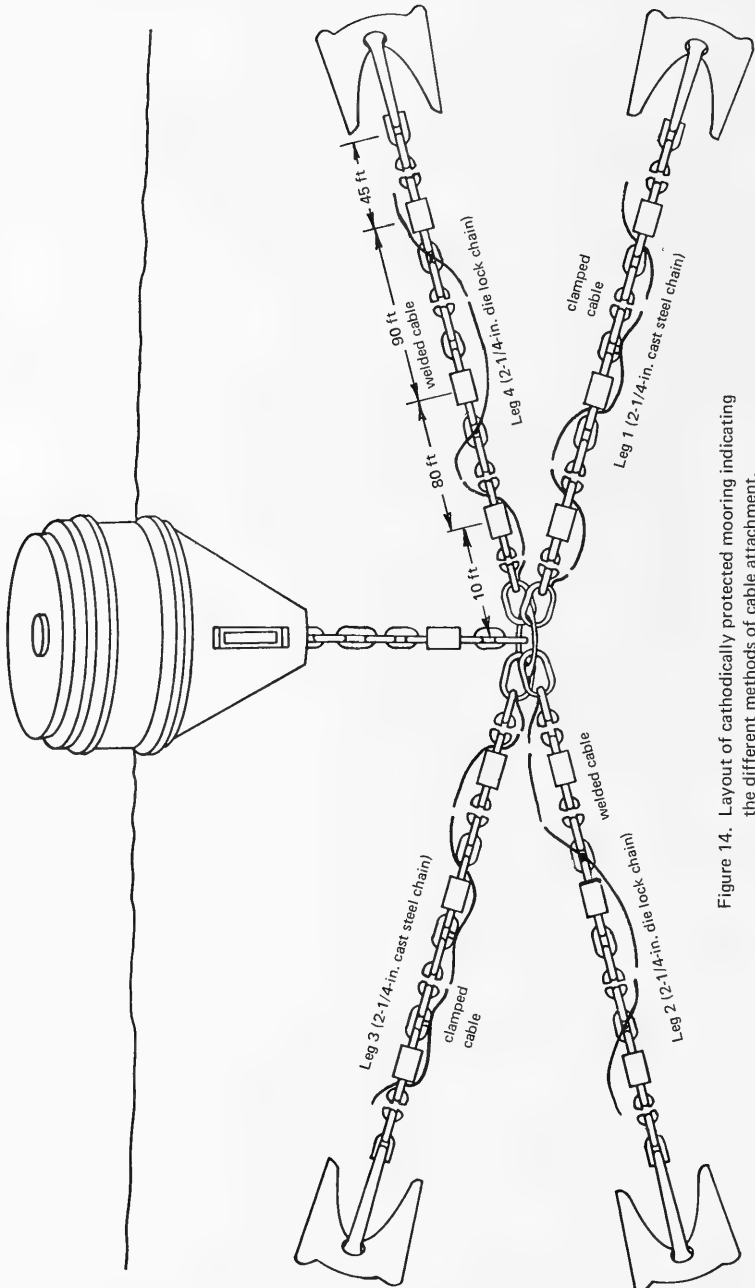
The modified cathodic protection design is shown in Figure 14. A single length of galvanized steel cable was loosely woven back and forth through every sixth link of each leg and was joined to the chain approximately every 5 feet. On two of the legs the joints were accomplished by silver soldering, and on the other they were accomplished with pipe clamps (Figure 15). The advantages of joining with pipe clamps were (1) it was faster, (2) it did not require the services of a welder, and (3) it did not require heating which might slightly decrease the strength of the heated link. The clamps were snapped into position and were then further tightened with a screwdriver. One pipe clamp was installed by a diver at the time of a later inspection to demonstrate that securing the cable underwater presented no real difficulty.

As shown in Figure 14, Legs 1 and 3 were of 2-1/4-inch cast steel chain with 3/4-inch galvanized steel cables clamped to them; Legs 2 and 4 were of 2-1/4-inch die lock chain with 3/4-inch galvanized steel cables welded to them. The cable on each leg was terminated approximately six links from the jew's harp of the anchor, rather than at the A-link nearest the anchor as in the previous test, to minimize current loss to the anchor. Thus, full protection of the chain was desired rather than partial or complete protection of the anchor.

Figure 14. Layout of cathodically protected mooring indicating the different methods of cable attachment.

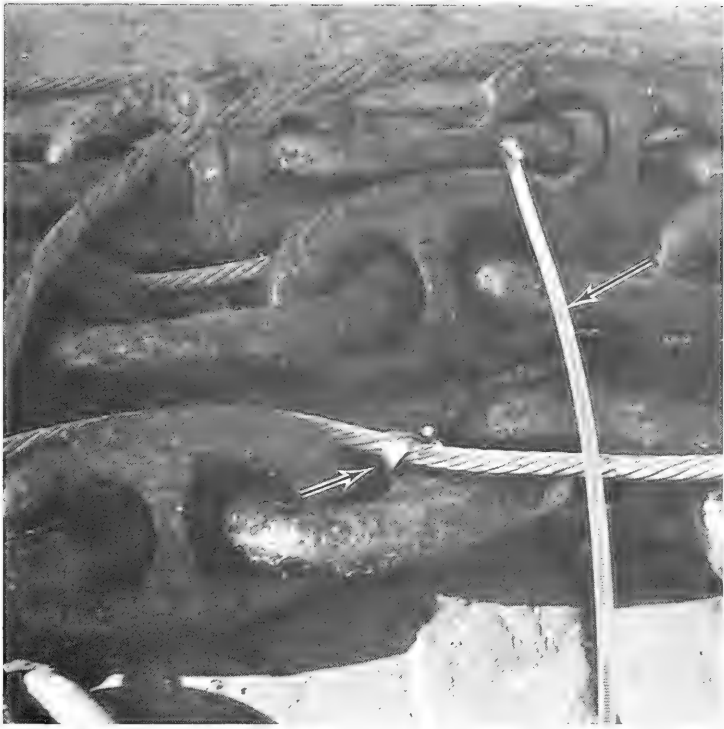
Figure 15. Cable clamped to chain link and a clamp shown prior to use.
